TRANE™

General Service Bulletin

HCOM-SB-71A

**SUBJECT: MODEL "E" COMPRESSOR TERMINAL BOARD RETAINING RING CAP SCREW
REPLACEMENT**

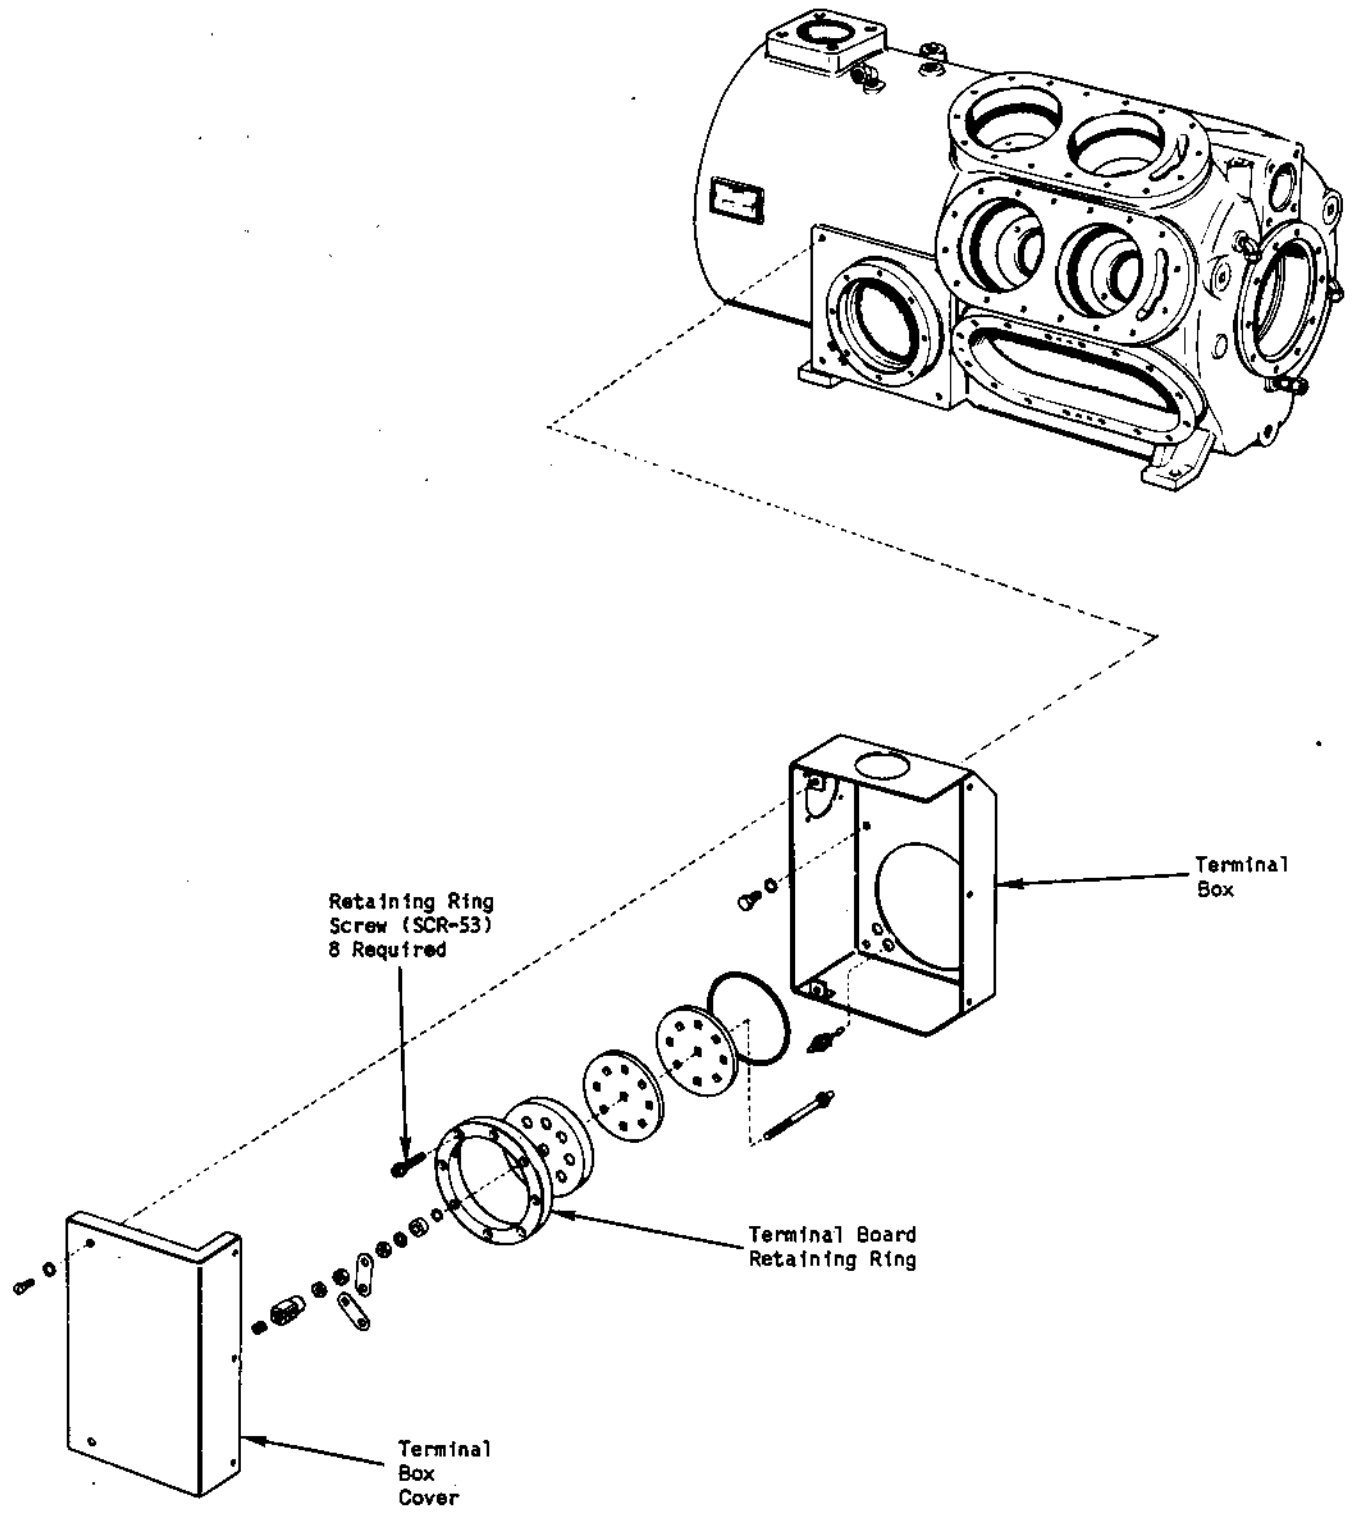
Figure 1
Retaining Ring
Cap Screw
Location

There have been several cases where the cadmium plated cap screws of the terminal board retaining ring on Model "E" hermetic compressors have failed. See Figure 1. This allows the terminal ring to separate, ripping the terminal box cover from the compressor. The cap screws, manufactured by Rockford Bolt, can be identified by an "R" on the head of the screw.

These cap screws have failed due to hydrogen embrittlement, which is caused by hydrogen being trapped in the screw during the plating process. This can result in the head of the screw popping off.

All cadmium plated screws produced by Rockford Bolt or Ferry, on Model "E" hermetic compressors with serial number prefixes *2G through *3M, must be replaced with new zinc plated cap screws, Trane part number SCR-53. Use the following procedure to change the cap screws:
