**General  
Service  
Bulletin**

**HCOM-SB-83**

**SUBJECT:** Scroll Discharge Line Failures - Review and Clarification

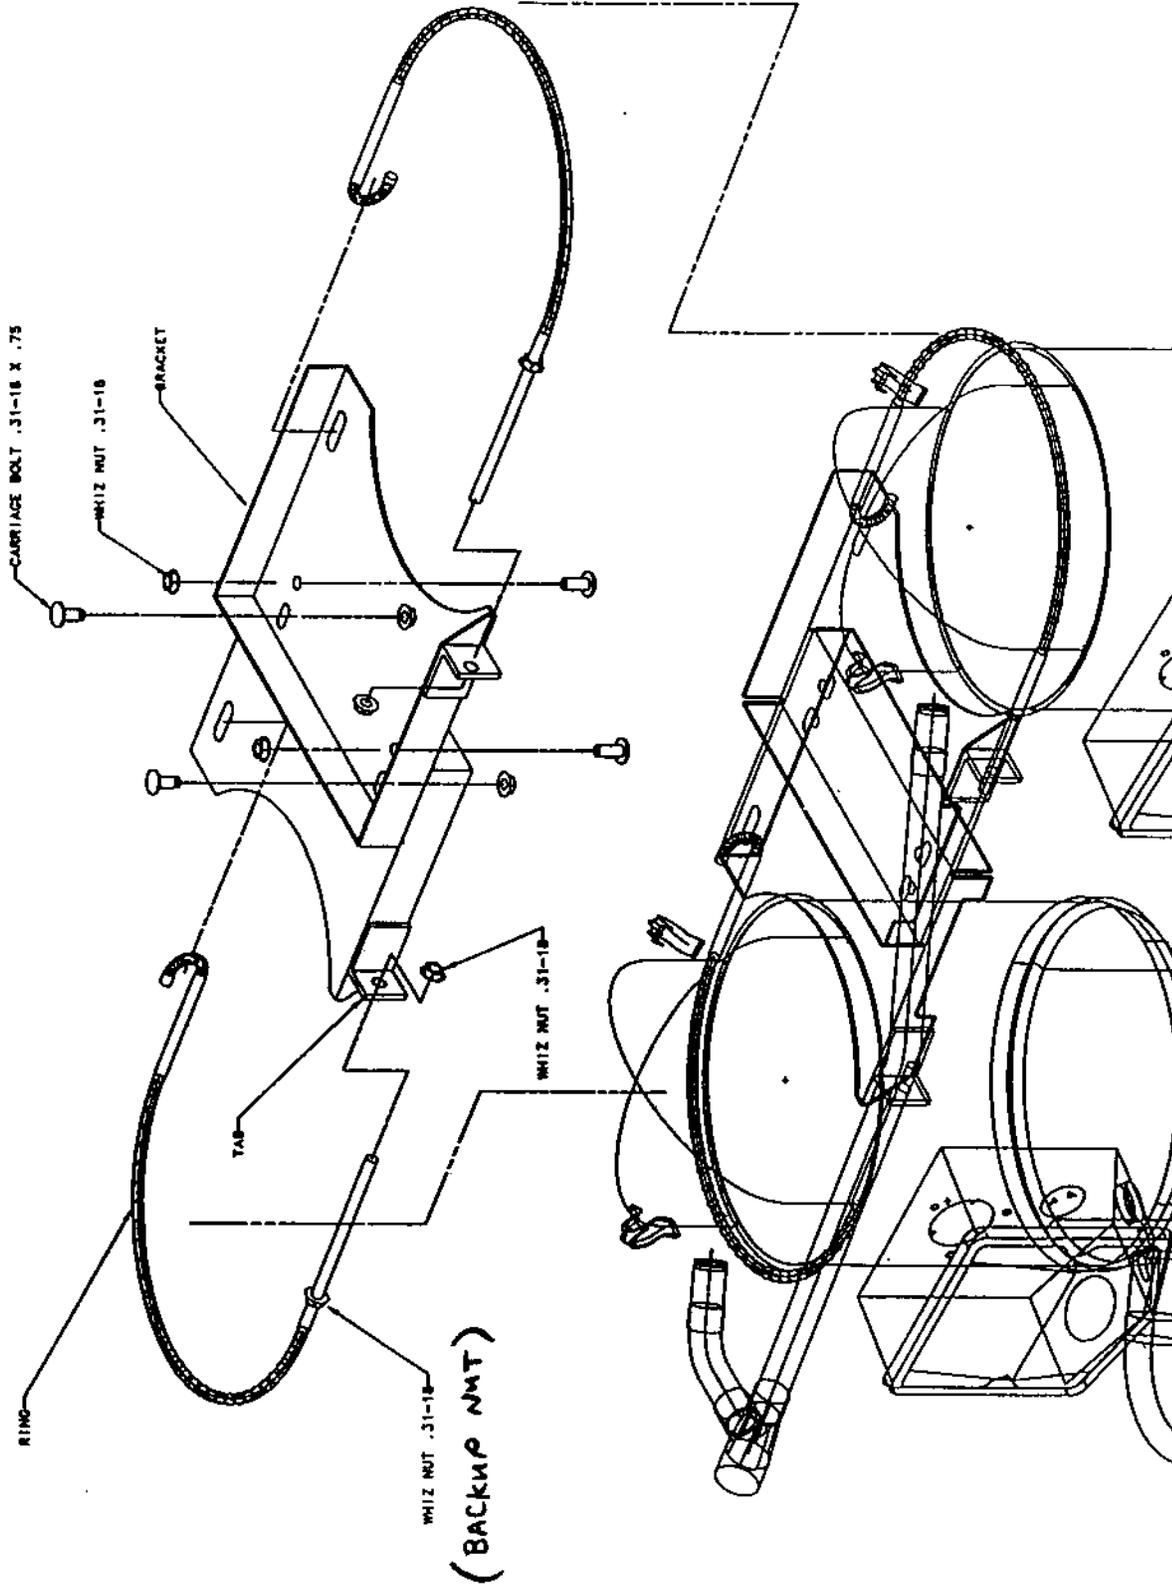
FIGURE 1

TYPICAL INSTALLATION FOR 20, 25 & 30 TON SCROLL

- (a) If brackets are installed, make sure they are correctly installed. Refer to Figure 1. Particular items to check include:
- proper orientation of the brackets
  - tightness of bolts
  - installation of the BACKUP NUT on the ring
  - all (4) bolts are installed
