TRANE
AIR CONDITIONING

SERVICE BULLETIN

No. **HCOM-SB-9**
DATE **2/6/76**
PRODUCT **RECIP. COMP.**
SERV. MAN. SECT. _____
PAGE **1-6**
T. GUTHRIE

SUBJECT: MODEL E COMPRESSOR, MECHANICAL FAILURES

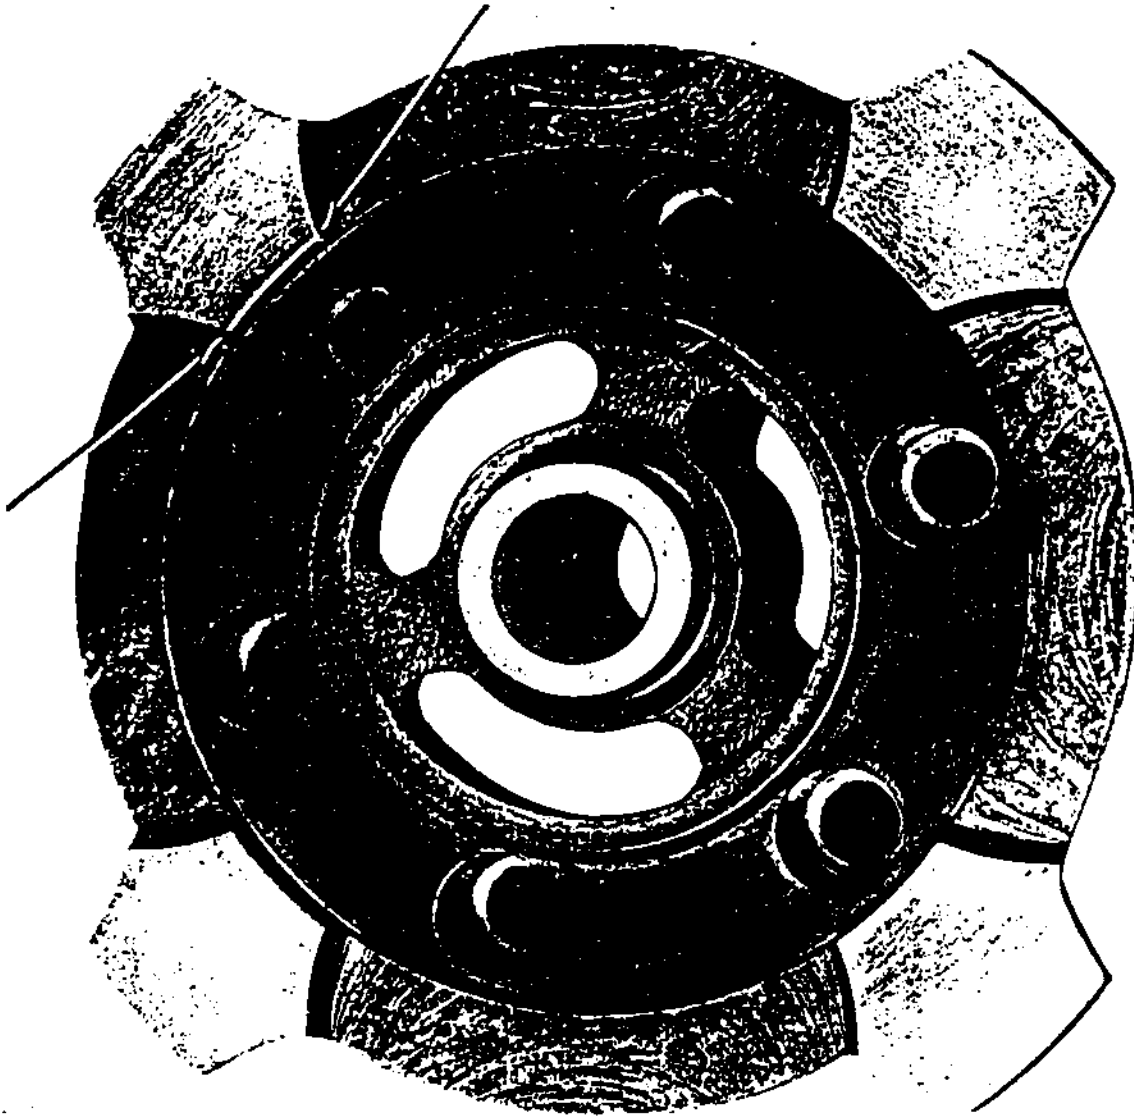
FIGURE 1

The reason for discharge valve hang-up is attributed to an incorrect or excessive chamfer on the valve operating counterbore. (See Figure 1). The chamfer should be approximately .005 to 0.010 inches deep. With this dimension the chamfer will appear as a very slight bevel.

If the chamfer is cut too deep, the discharge valve can move out of its operating counterbore and be caught between the discharge cage and suction valve plate, if the cage also lifts off the suction valve plate.

Check the chamfer on each of the discharge valve cage assemblies prior to installation. The chamfer should be cut at approximately .005 to .010 of an inch. A simple test may be used to determine whether or not the cage is usable. The valve should be depressed as far as possible on one side and then pushed sideways to see if the valve can be pushed out of its normal counterbore. Any cage found in which the valve may be displaced should not be used when rebuilding a compressor.

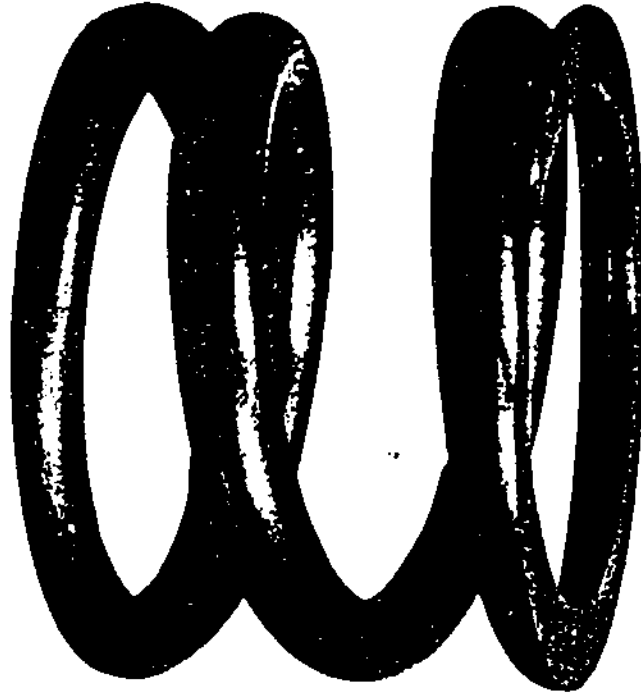
The cylinder head spring was changed in 1972 from three to three and one half total coils as shown in Figure 2 and 3. The wire material was also

FIGURE 3 - New 3 1/2 Coil

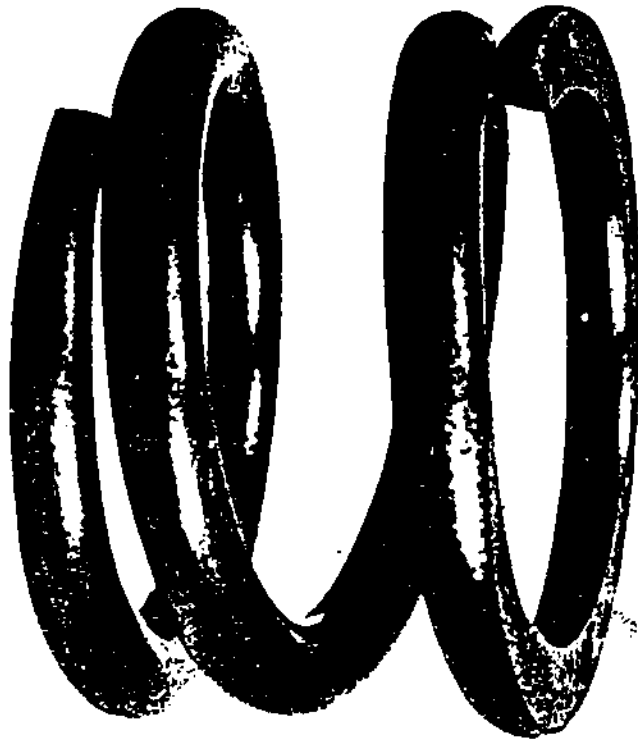
Reinstallation of a short spring during overhaul may allow the discharge cage assembly to lift during normal operation because of insufficient spring compression. The cage movement coupled with the possibility of the discharge valve moving sideways from its normal position will prevent the valve from seating thus allowing continuous hot gas leakage to the top of the piston. When this occurs, alternate loading of the bearings is interrupted which can cause an eventual compressor failure.

FIGURE 2 - Old 3 Coil

If the old style cylinder head spring (see Figure 2) is being reused for overhaul, check to see that the spring has not taken a set. Place the spring on a flat surface and lay a straight edge on the top of the spring. Rotate the spring 360° to determine the minimum free length. Minimum free length for a reusable head spring is 2.47 inches.

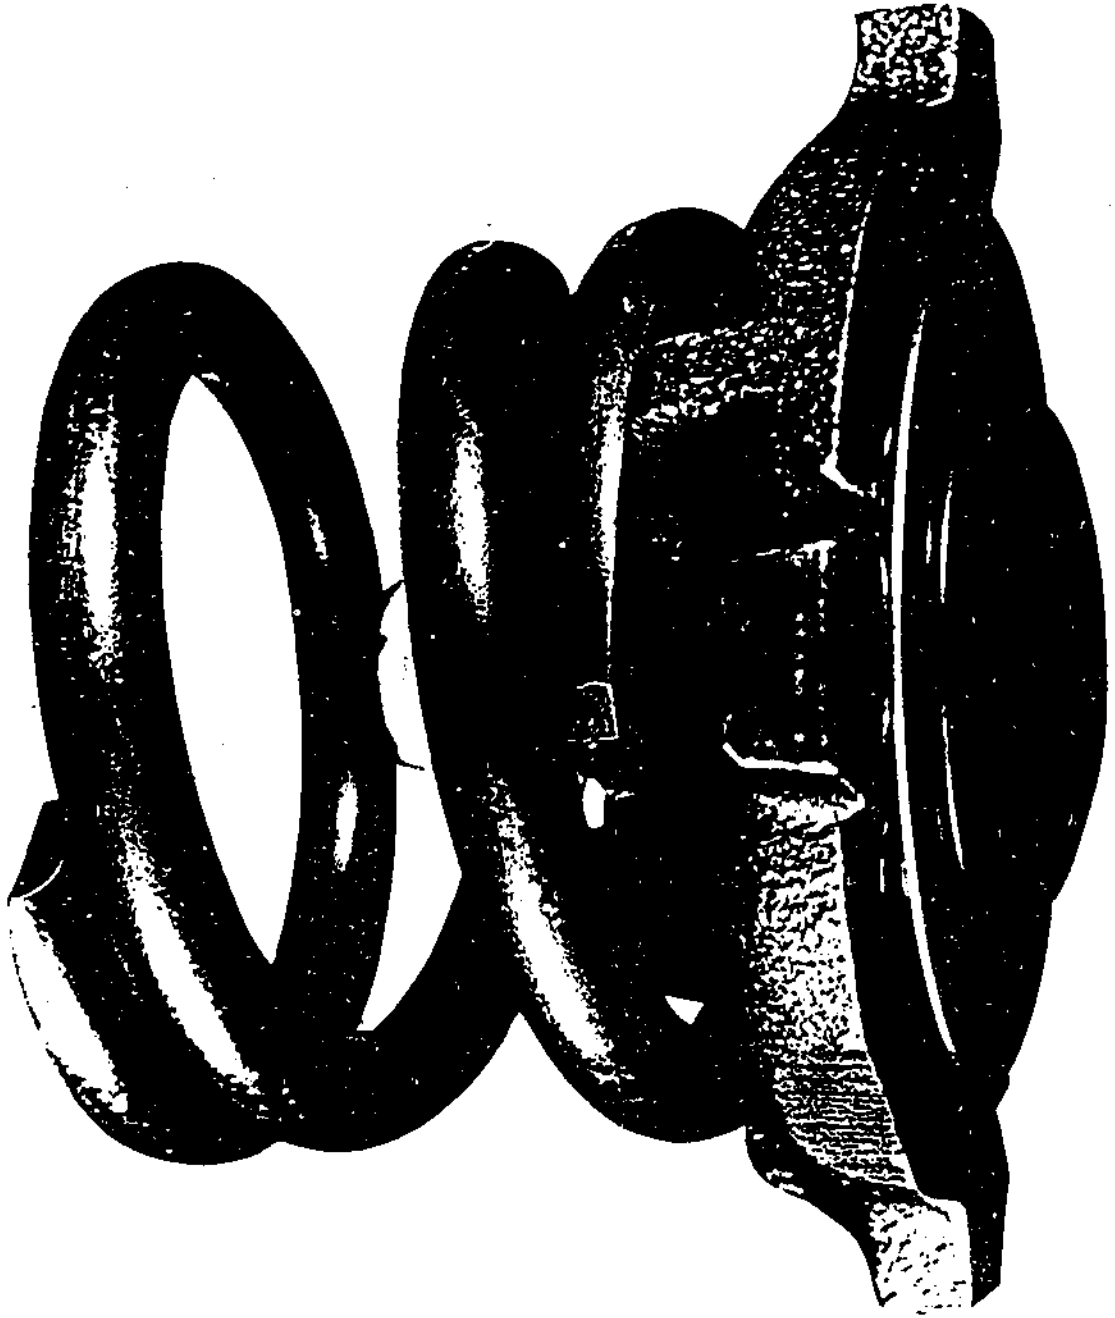
FIGURE 4 - Cylinder Spring Installed Correctly

When reinstalling either style spring it is possible to improperly position the spring as described in Section 2 above. Be sure the start of the spring, when placed on the cage assembly, is located as shown in Figure 4.

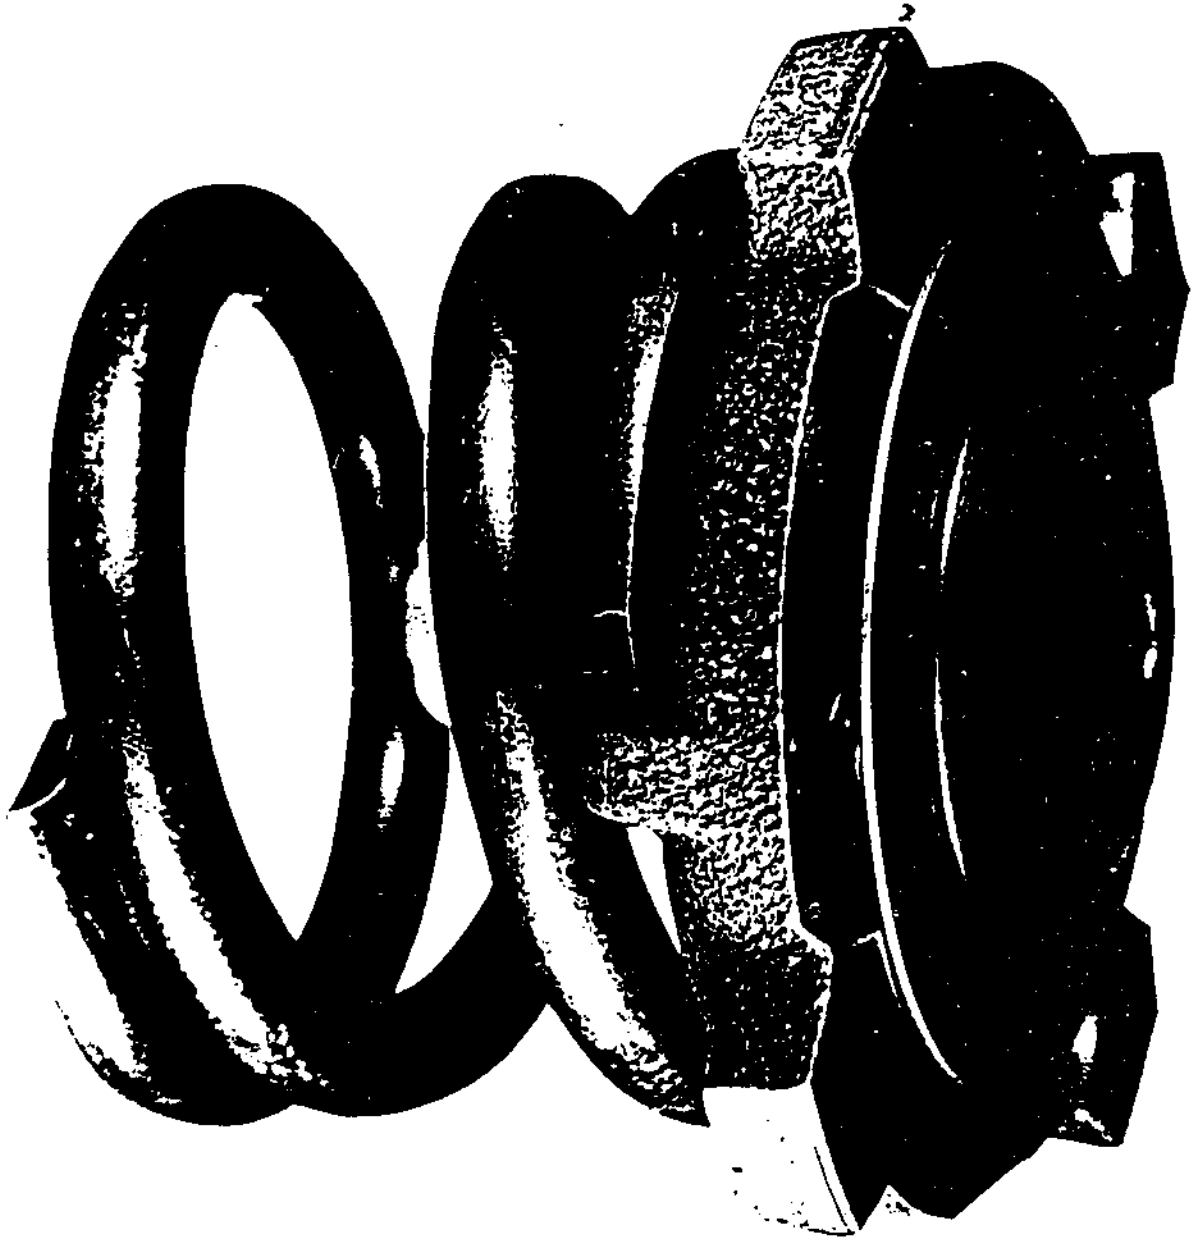
Improper spring positioning can occur when using either style cylinder head spring (three coil turns vs three and 1/2 turns) and positioning the start of the spring on a supporting rib on the discharge cage assembly as shown in Figure 5.

Improper spring position can allow movement (tilting) of the discharge cage assembly, resulting in excessive noise, probable discharge valve seating problems, and potential mechanical failures.

FIGURE 5 - Cylinder Ring Installed Incorrectly
