FILE INFORMATION:
DIVISION TAB-TRANE REFRIGERATION
PRODUCTS
PRODUCT TAB-RECIPROCATING COM-
PRESSOR-CONDENSER
UNITS
MODEL TAB-Hermetic M-R
LITERATURE ITEM-GENERAL SERVICE
BULLETIN

HCOM-SB-49

**GENERAL
SERVICE BULLETIN**

SUBJECT: RECIPROCATING COMPRESSORS, ALL MODELS - OPERATING OIL LEVEL

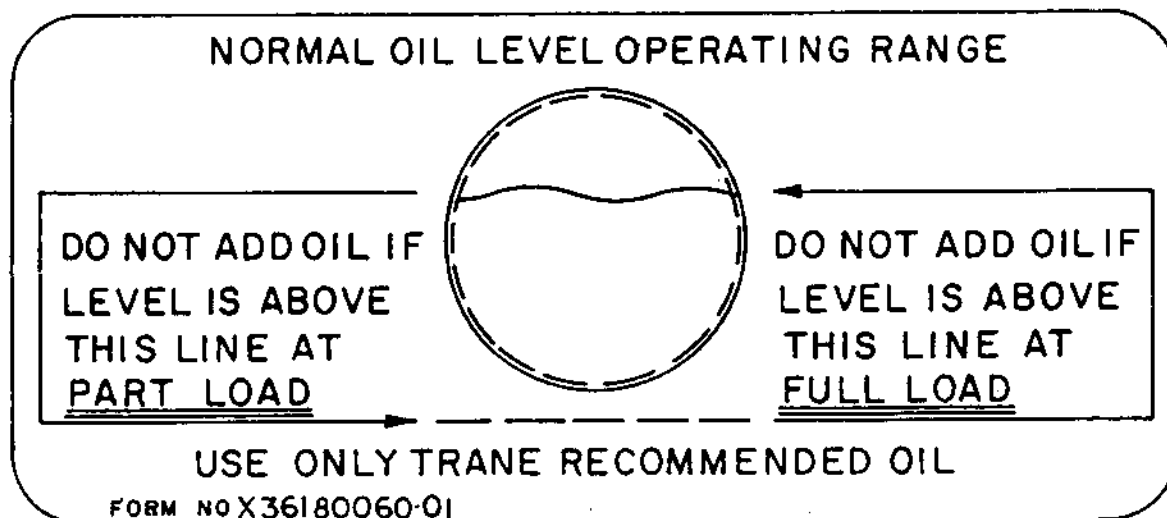
The oil levels on all Trane Compressors may vary due to the load conditions of the system. The oil level may vary from halfway up the sight glass to 1/4" below the bottom of the sight glass on the compressor.

An excessive oil charge is indicated when the oil level in the sight glass of a compressor operating at full load is over the halfway mark.

1. When customers report low oil levels, tell them what causes variation in oil level and corrective steps to be taken.
2. Always determine reason why oil pressure control is stopping compressor and take corrective action. Oil does not leave a system or a compressor without a reason.
3. On oil change or after compressor repair, add only the same amount of oil that was removed from the system.
4. Provide oil level operating range decals for attachment to the compressor terminal box cover. (See Figure 1).
